Diametric growth detection on reactor charge heater radiant tubing

CASE STUDY

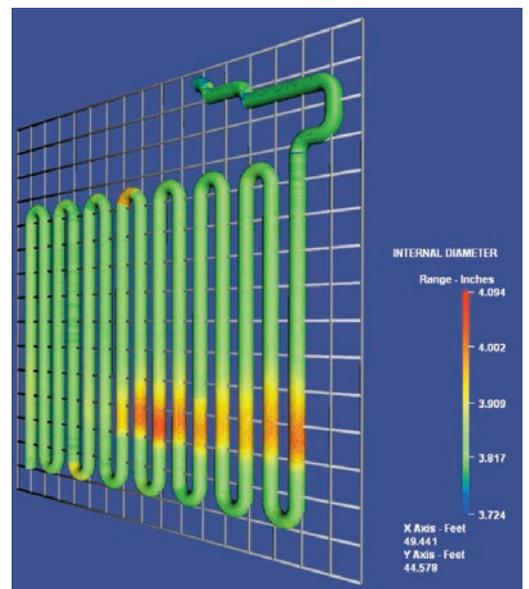
Significant diametric abnormalities were identified within the radiant coils of passes 1, 2 and 3. These abnormalities were more abundant in Pass 2, with diametric growth up to 4.7% (Pass 2, Tube 7) observed. This phenomenon was clearly visible in the 3D C-Scan and accompanying graphical plots (Figures 2, 4(a) & 4(b)). The diametric anomalies were considered to be “irregular” due to the consistent swelling around the full circumference of the tubes, as opposed to ovality or localized bulging on the fire side of the pipe-work. The tube wall thickness was seen to be constant throughout the radiant tubing, with minimal deviation from the nominal value. This can be seen in the graphical plot shown in Figures 3 and 4(c).

Figure 2: Pass 2 Internal Diameter 3D C-Scan showing diametric growth in Radiant Coil 2

Following the Inspection, the tubes that were identified as damaged were removed upon Cokebusters advice. All defect quantification and location was confirmed by the client, who remarked that this damage would almost certainly have gone undetected using conventional NDT methodologies.

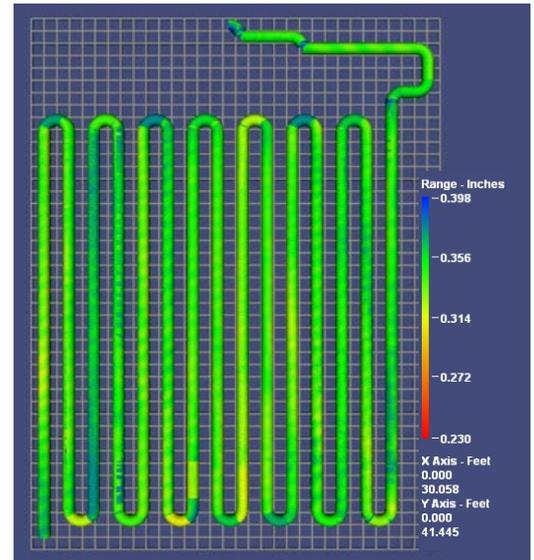
Figure 3: Pass 2 Wall Thickness C-Scan

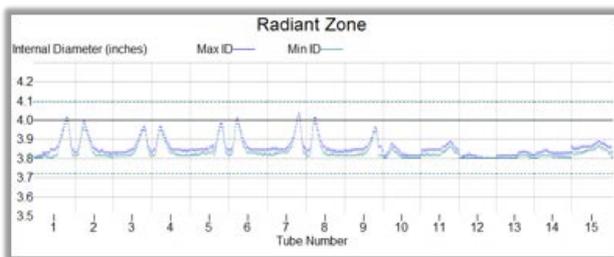
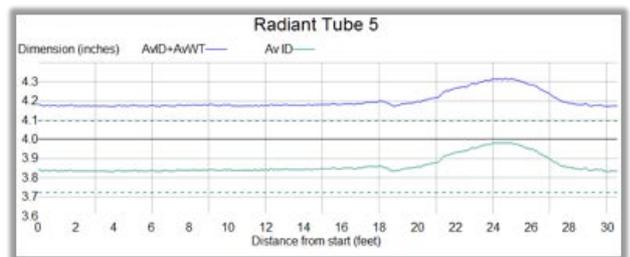
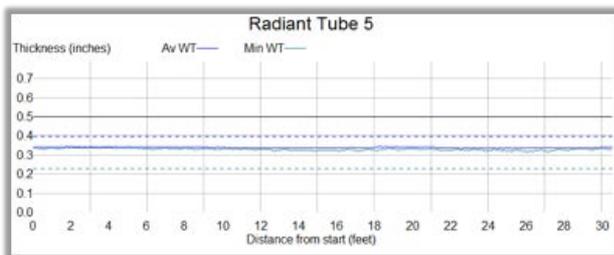
Following the inspection, a full Level III Fitness for Service assessment was carried out in accordance with API 579-1/ASME FFS-1. Visual examination, microstructural analysis and micro-hardness measurements were conducted on the heat affected areas. Scanning Electron and Optical microscopy confirmed the presence of ferrite and martensite in the heat affected areas, indicating that the tubes were exposed to skin temperatures in excess of 750°C, with a high rate of cooling experienced. The micro-hardness measurements obtained in these areas further confirmed exposure to excessive temperatures and were attributed to strain hardening resulting from plastic deformation from exposure to elevated operating temperatures and pressures. Overheating reduced the tube strength sufficiently that the internal stresses exceeded the yield strength of the tubes, which ultimately led to diametric swelling. Upon discussion with the client, it was concluded that the radiant tubes were subjected to short-term overheating during operational shutdown, which ultimately led to the tube bulging and diametric deformation within the radiant tubing. Long-term creep damage was ruled out due to the uniform concentric swelling, accurate burner alignment and known historic operating temperatures outside of the creep regime.

Figure 4: Graphical plots showing (a) Diametric increase in Radiant Tubes 5-9 (Inclusive), (b) Average diametric growth in radiant tube 5 and (c) Wall thickness profile along radiant tube 5
