External high temperature oxidation

in a vacuum distillation furnace

CASE STUDY

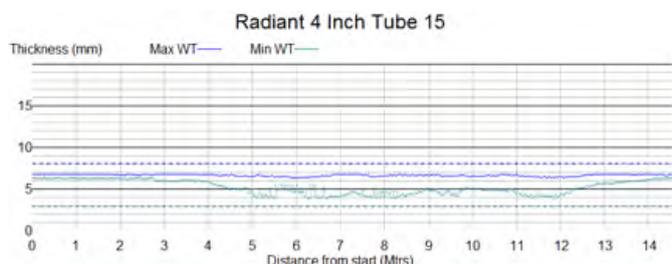
A similar pattern of wall loss was observed in all 8 of the radiant 4-inch sections of tubing, with Pass G containing the most severe damage. This wall loss was particularly pronounced within the tubes located at the middle areas of each coil (Tubes 11 to 21, Figure 2). Correlation with the internal radius measurements obtained from the intelligent pig confirmed that the wall loss was predominantly external. After consultation with the Cokebusters mechanical decoking Technicians, it was verified that these particular radiant areas also showed the highest level of internal coke contamination. Figure 3 shows a cross-sectional tube image taken from one of the affected areas. The data table below the image clearly identifies the extent and orientation of the wall loss at this particular axial location. Figure 4 displays the 3D wall thickness C-scan obtained from Pass G.

Figure 2: Graphical plots showing the correlation of internal diameter and wall thickness within a heat-affected tube.

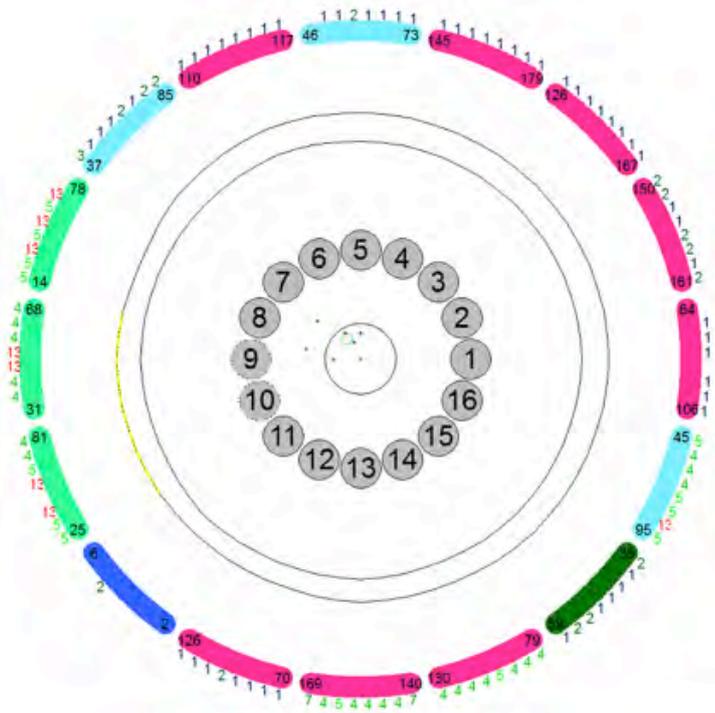
Following consultation with Refinery Engineers, it was hypothesized that the damage mechanism was due to localized flame impingement, which was ultimately caused by burner misalignment. The elevated skin temperatures within these areas accelerated internal coke build-up at the heat-affected zones, which was confirmed by the Cokebusters mechanical decoking Technicians. The insulating coke layers further increased the skin temperatures, which ultimately led to severe external oxidation.

Figure 3: Cross-sectional tube image obtained from an area of external wall thinning.

Radiant 4 Inch Tube 14

Length: 14.54 Dia.: 102.3 (+507-2.0) Wall: 6.0 (=2.0-1.5) Pos.: 8.56mtrs

Following the Inspection, the tubes that were identified as damaged and below the calculated corrosion allowance were removed upon Cokebusters advice. All defect quantification and location was confirmed by the client using manual UT methods.

Burner alignment was reviewed and adjusted accordingly. Regular mechanical decoking and intelligent pigging operations were also recommended to eliminate the potential for similar future damage. It was also suggested by the client that no other commercially available intelligent pigging system has the capability of navigating plugged headers with similar geometry to those found within these radiant coils, making the Merlin inspection system a unique intelligent pigging service.

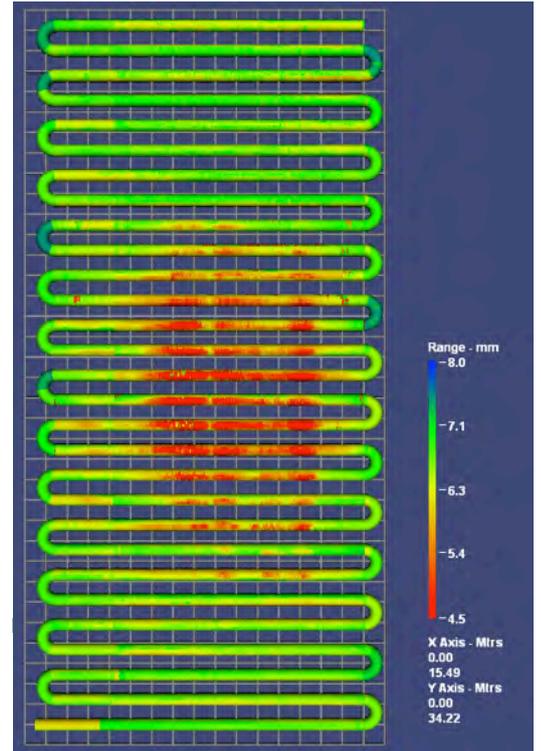
Figure 4: Wall Thickness 3D C-Scan showing External Wall Loss in Radiant Coil 2.
